Sliding Friction and Wear Behaviour of Titanium-Zirconium-Molybdenum (TZM) Alloy against Al_2O_3 and Si_3N_4 Balls under Several Environments and Temperatures

Due to its resistant to thermal shock and strength at elevated temperature, Titanium-Zirconium-Molybdenum (TZM) alloy is used for hot-work tooling up to 1500°C. The friction and wear behaviour of the TZM alloy reciprocating against Al_2O_3 and Si_3N_4 in different conditions were investigated. It has an adhesion and/or oxidation character with a high coefficient of friction when dry sliding against an alumina ceramic ball. It is characterised with reduced wear in an abrasion mode when reciprocally sliding against a Si_3N_4 ceramic ball. In addition, the friction and wear between TZM and an Al_2O_3 ball under unidirectional sliding conditions can be reduced when lubricating molybdenum oxides was formed at higher temperature i.e. 600°C. Finally, the friction and wear mechanisms involved are discussed.

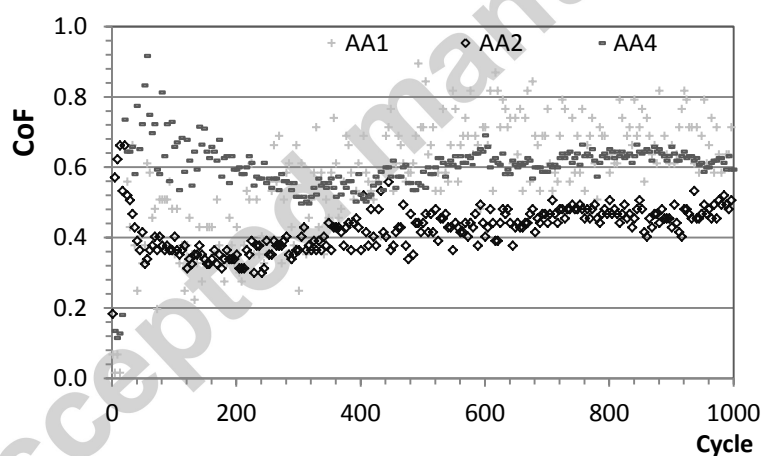
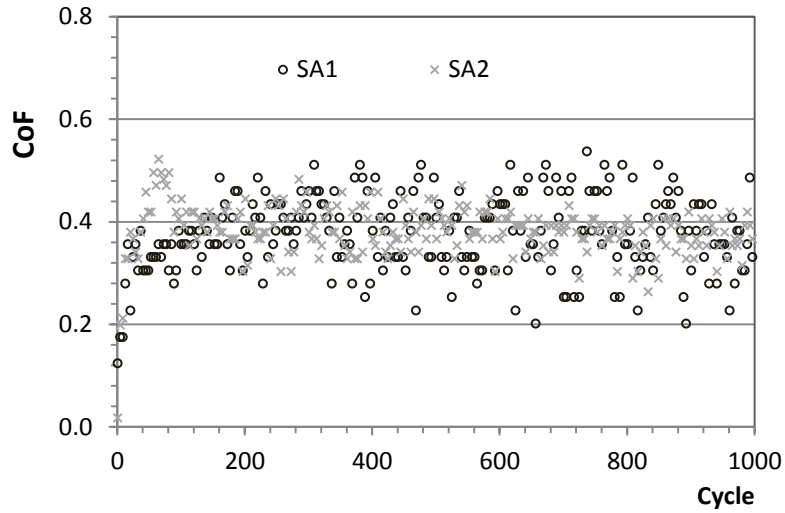
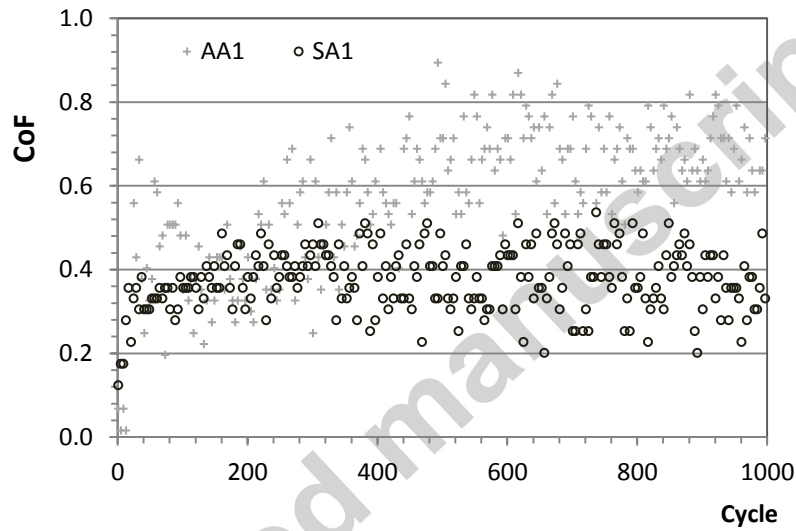
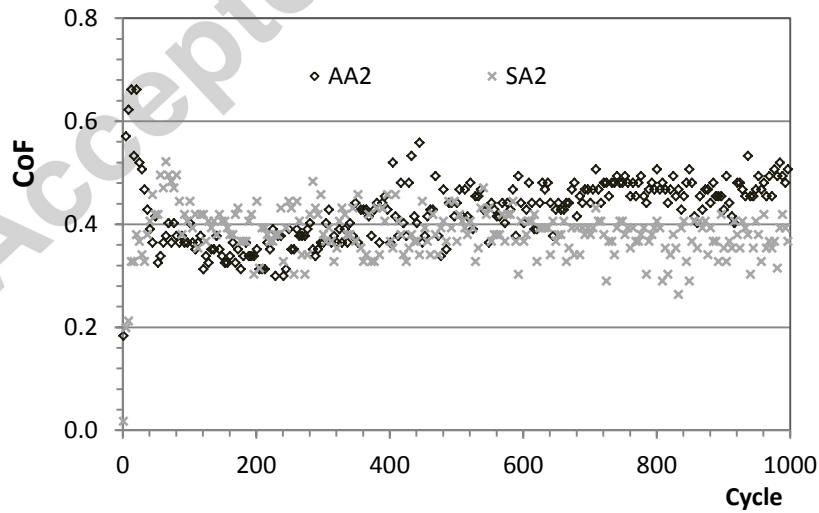
Figure 1. The coefficient of friction of TZM against moving cycles in air: (a) alumina ball under 1, 2 and 4 N, (b) Si_3N_4 ball under 1 N and 2 N, (c) alumina and Si_3N_4 ball under 1 N and (d) alumina and Si_3N_4 ball under 2 N.

Figure 1 shows the change of coefficient of friction (CoF) of TZM sample against reciprocating cycles in the air as a function of counterpart balls (Al₂O₃ and Si₃N₄) and loads (1N, 2 N and 4N). As seen in Figure 1a, under a load of 1 N with an Al₂O₃ counterpart ball (AA1), the CoF of the TZM sample climbed up to as high as 0.8 at the beginning and then gradually reduced to about 0.5 till about 200 cycles; this value was slightly up and scattered in a big range between 0.5 and 0.9. When a load of 2 N (AA2) was used, the CoF developed similarly as AA1 but the values (0.3-0.5) were generally lower than that tested under 1 N load (AA1) and less scattered in the whole test. The CoF (AA2) remained between 0.35 and 0.5 after 500 cycles even in an extended test (AA22, 2000 cycles). When a load of 4 N (AA4) was used, the CoF of the TZM sample climbed up to as high as 0.94 at the beginning and then gradually reduced to about 0.5 after about 300 cycles; this value was slightly up and fluctuated around 0.62.

When changing the counterpart ball to Si₃N₄ (Figure 1b), the CoF of the low-load (1 N) SA1 sample increased gradually to a value around 0.4 after about 100 cycles. When changing the load to 2 N, the CoF of SA2 increased rapidly to 0.52 within about 65 cycles before reducing to a similar average value around 0.4 with relatively small fluctuation range in comparison with that tested under a load of 1 N (SA1).

same medium like air. As displayed in Figure 1c, when tested under 1N, although the friction fluctuated greatly for both counterparts, except for the initial 200 cycles the average CoF is much higher when against the Al_2O_3 ball (~ 0.6) than against the Si_3N_4 ball (~ 0.4). However, when tested under 2 N, the initial CoF was higher when against the Al_2O_3 ball (AA2) than against the Si_3N_4 ball (SA2) but they were gradually levelled after about 100 cycles to around 0.4 and the CoF of AA2 was slightly higher after 500 cycles as seen in Figure 1d.

As shown in Figure 1a, under a load of 1 N (AA1), the CoF of the TZM sample remained high and scattered largely throughout the whole tribotest. The CoF became lower and less scattered when the load was increased to 2 N (AA2). When increasing the load to 4 N (AA4), initially the CoF of TZM sample against an Al_2O_3 ball was higher than that tested under the lower loads (1N and 2N); however, at a later stage, it remained higher than that test under 2 N (AA2) but lower than that tested under 1 N (AA1).

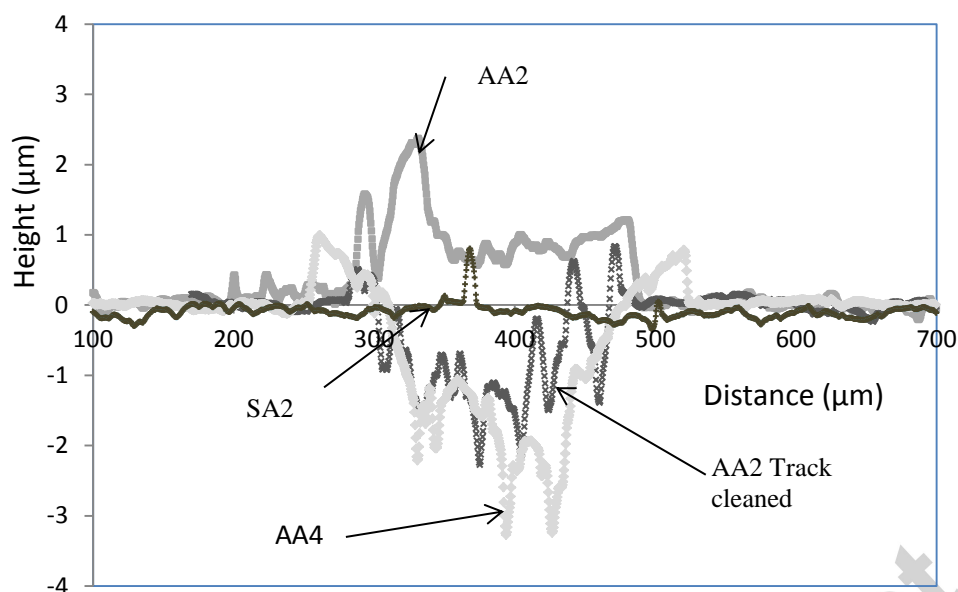
Figure 2. The wear tracks on TZM sample plotted by a 3-D profilometer after friction test of 1000 cycles in the air with different balls.

After the test, the wear tracks were measured by a 3D profilometer and plotted in 2-D profiles across the wear track (Figure 2). It can be clearly seen that a clear, deep concave wear track was produced by an Al_2O_3 counterpart ball under a load of 4 N (AA4); but a prominent plateau wear track was found after tests under loads of 1 N and 2 N against the same Al_2O_3 counterpart ball (only AA2 presented). However, when the track was cleaned by a plastic brush, a concave wear track was revealed (see Figure 2, AA2_track cleaned). After being rubbed against a Si_3N_4 counterpart ball under a load of 2 N, the wear track was hardly measurable even after cleaning (SA2 in Figure 2).

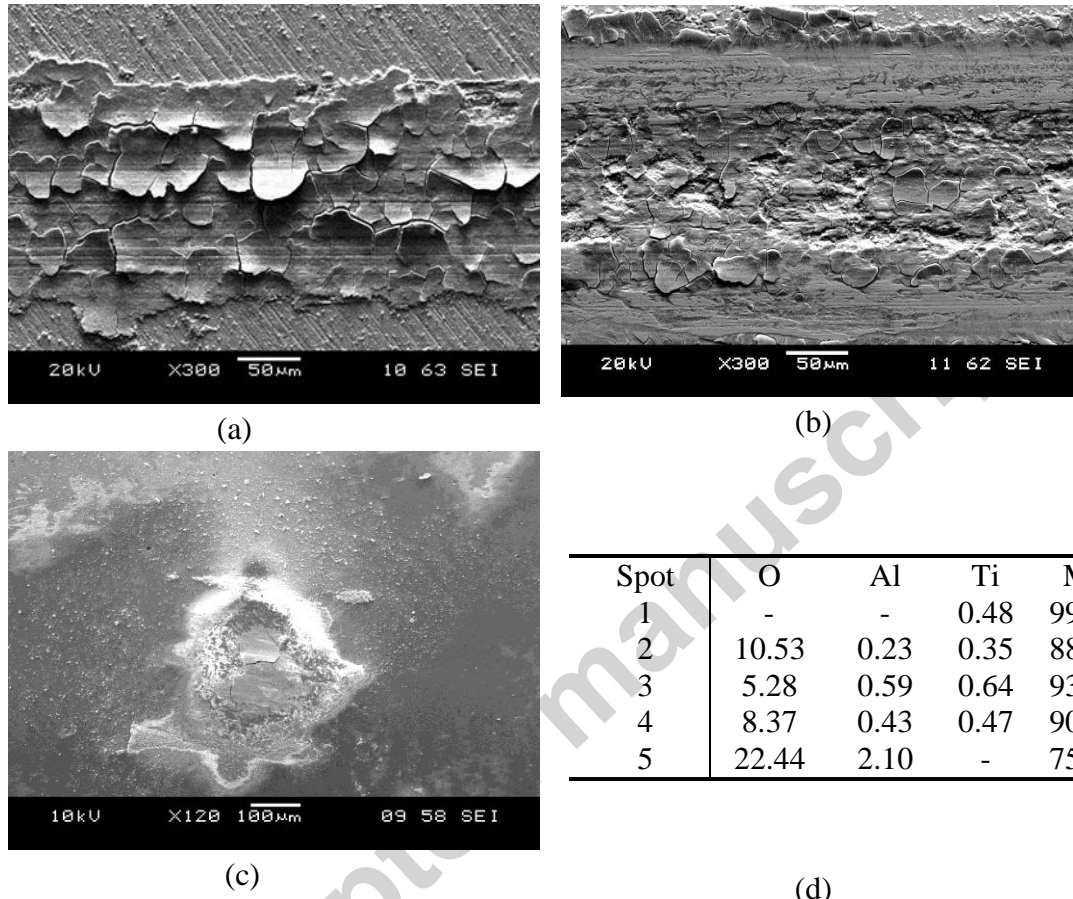
Figure 3 Wear tracks after friction test: (a) AA2, (b) AA4, (c) crater on AA4 counterpart Al_2O_3 ball and (d) EDX analysis

SEM observations revealed flake featured wear track surfaces for AA1 and AA2 tested samples (Figure 3a). However, when tested under 4N, the wear track formed on the AA4 tested sample was only partially covered by the flake-like feature (Figure 3b) together with some wear craters and grooves. EDX analysis at different spots of the wear tracks and the substrate was conducted and the results are shown in Figures 3a, b&d. As expected, the substrate (Spot 1) is dominated by Mo with 0.48% Ti. However, although the flake (Spot 2) formed on the wear track of AA2 tested sample was still dominated by Mo, it contained a high amount (10.53%) of oxygen and a small amount of aluminium. This indicated that the flake formed on the wear track surface was likely to be a product of molybdenum oxides with a little aluminium-containing debris from the counterpart Al_2O_3 ball. The flakes observed from the wear track of AA4 tested sample (spot 4 in Figure 3b) had a similar composition as for Spot 2, while Spot 3 taken from the crater had less oxygen (5.28%) than Spot 2 (10.53%).

the Al_2O_3 ball, and EDX analysis (Spot 5 in Figure 3c) revealed a high amount of molybdenum (75.47%) and oxygen (22.44%) but a low content of aluminium (2.10%). This evidenced that very mild wear occurred to the Al_2O_3 ball but the TZM sample was worn by Al_2O_3 ball severely and the wear debris was transferred to the Al_2O_3 ball during the wear tests.

Further sliding and rubbing between the Al₂O₃ ball and the TZM sample led to the oxidation of the flaky molybdenum pieces in some local points. As evidenced in Figure 3d, oxygen content varied at different locations in the wear track produced, which implies that different oxides might have been formed. Oxides like MoO₃ and Mo₄O₁₁ are Magnéli phases, which has a similar structure like graphite, and they have lubrication effect at elevated temperature but lose it at room temperature [7, 10, 17]. The friction was slightly reduced (AA4) after the initial high friction period. This might be due to the lubricating effect of the molybdenum oxides formed in certain areas where severe rubbing raised the local temperature, which is in agreement with Portu's findings [13]. After certain reciprocating cycles, the oxidised flaky pieces were peeled off from the surface and some of the particles would stay between the tribo-pair acting as third-body objects (Figure 14b). The mixed milled oxides and wear particles increased the wear of TZM and thus a deep concave wear track was formed (Figure 14c). The wear mechanism is dominated partially by oxidation wear and partially by adhesive wear. Similarly, Lucchini [18] found molybdenum tended to adhere to aluminium and easily peeled off from the Mo/Al₂O₃ cutting tool during machining Al/Al₂O₃ composite.

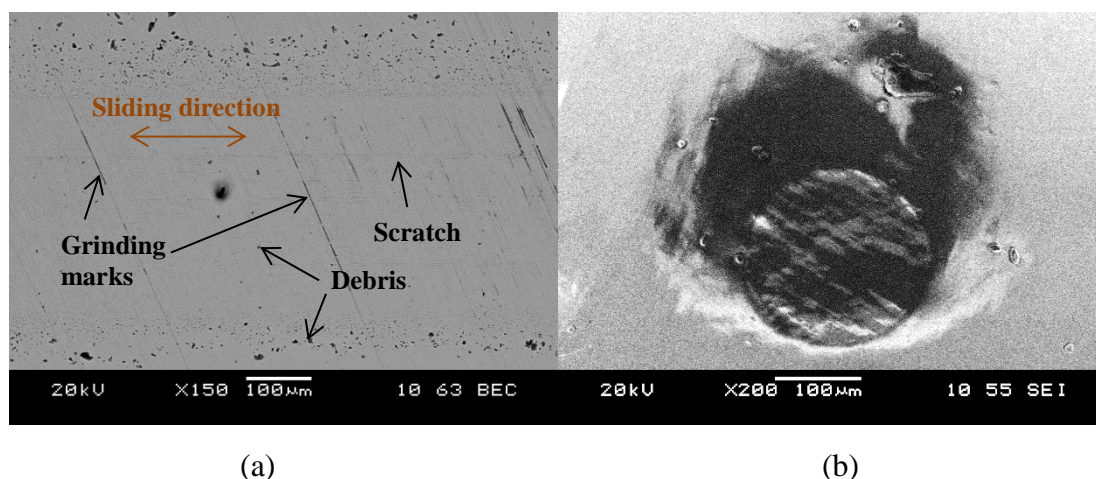
Figure 4. Wear tracks after friction test: (a) SA2, (b) Crater on counterpart Si_3N_4 ball

In contrast, the wear track formed on TZM surface by sliding against a Si_3N_4 ball in the air was barely visible and only some minor scratches were found regardless of the loads applied as indicated in Figure 4a. Indeed, some of the grinding marks produced during sample preparation remained after the test. This indicated very mild wear, which is in line with the 2D profile across the wear track formed on the SA2 tested surface (see Figure 2). Some wear debris was in clear contrast with the base material in a backscattering electron image and EDX analysis identified high silicon content in the debris. A relative flat wear surface was observed on the Si_3N_4 ball, indicating clearly material lost from the ball during the tribo-tests (Figure 4b).

The tribological behaviour (especially wear) of TZM alloy reciprocating against a Si_3N_4 ball differs greatly from against an Al_2O_3 ball. For example, when tested in air under the same normal load of 2N, whilst a deep wear track was produced in TZM surface by reciprocating against an Al_2O_3 ball, no measurable wear to TZM surface was observed after reciprocating against a Si_3N_4 ball (Figure 2). The corresponding surface wear morphologies are also different. As shown in Figure 3a, the wear track produced by reciprocating against an Al_2O_3 ball were covered by flaky wear debris while there were only a few minor scratches appearing in the wear track produced by reciprocating against a Si_3N_4 ball (Figure 4a). In addition, a clear flat wear surface was formed on Si_3N_4 ball (Figure 4b) but very mild wear occurred to the Al_2O_3 ball.

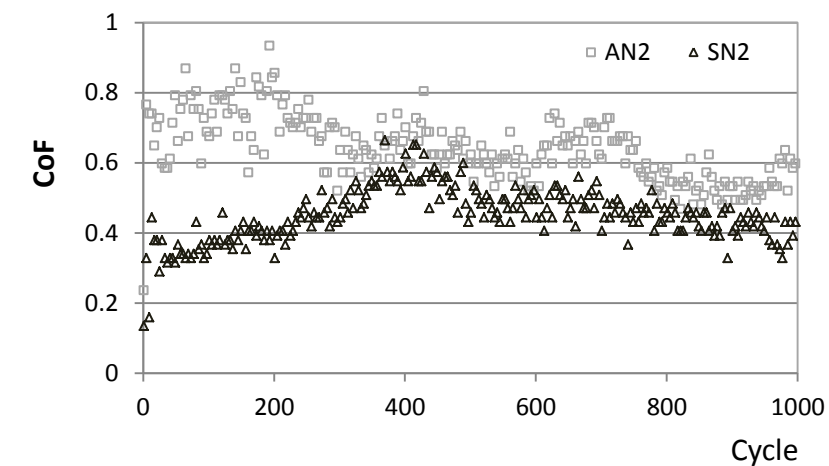
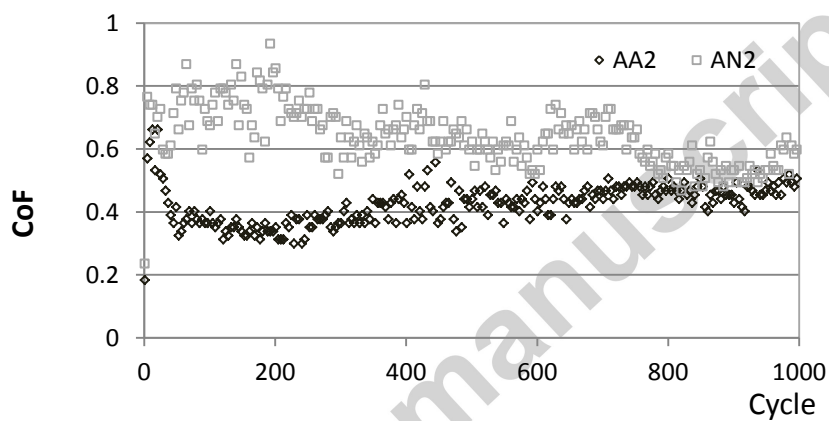
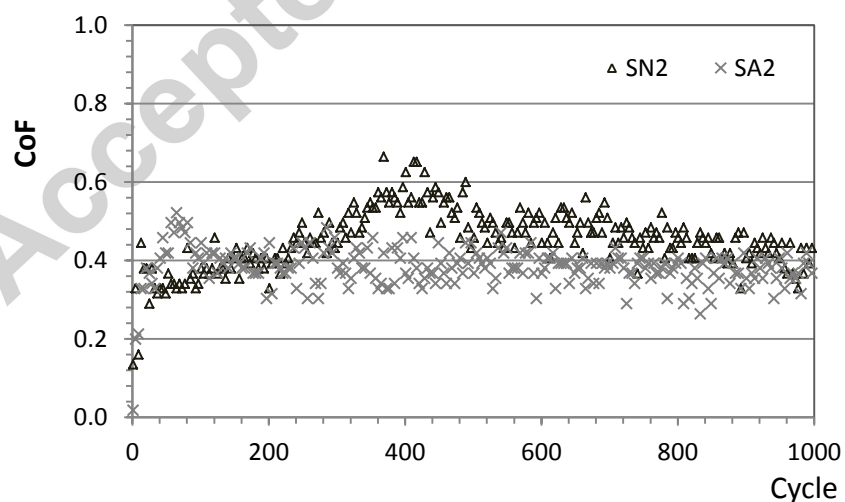
Figure 5. The CoF against cycle between TZM and (a) different counterpart balls in nitrogen (AN2 vs SN2), (b) Al_2O_3 ball in air (AA2) and in nitrogen (AN2) and (c) Si_3N_4 ball in air (SA2) and in nitrogen (SN2).

The CoF of the AN2 tested TZM sample started at around 0.8 and then declined gradually but periodically with the tests cycles to about 0.5-0.6 after 1000 cycles (Figure 5a). The CoFs for AN2 were generally higher than those tested in air (AA2) especially in the first half of the tribo-test process (Figure 5b).

The friction between a Si_3N_4 ball and the TZM in nitrogen (SN2) was quite similar to that tested in air (SA2) under otherwise same conditions (Figure 5c). For both tests, the CoFs increased with the cycles to a peak before it decreased to a similar level. It was noted that the CoF peaked after about 65 cycles when tested in the air but after 400 cycles when tested in nitrogen.

It can be seen by comparing Figure 1a with Figure 5a that, when tested under the same load of 2N, the CoF of the $\text{Al}_2\text{O}_3/\text{TZM}$ was increased from about 0.4 when tested in air (AA2) to about 0.6 when tested in nitrogen atmosphere (AN2). This is mainly because oxides were difficult to form in a nitrogen atmosphere due to the lack of oxygen after initial galling, thus reducing the potential lubrication effect of oxides. Once the material was torn apart, more galling occurred in the tribo-test, which led to a very high CoF as shown in Figure 5a. Elemental information collected by EDX revealed that the oxygen content detected in the wear groove was much lower than that in the flakes. This could be due to the deficient of oxygen during tribo-test at the contact area or the removal of the flakes (Figure 7). In this case, some metal particles rather than oxide pieces were peeled off and acted as abrasive particles between the ball and the substrate thus increasing the friction and wear. However, it is not clear why the friction was then gradually reduced with the progress of the tribo-test. One possibility would be the effect of wear debris, which changed high-friction two-body abrasive wear to low-friction three-body abrasive wear due to the rotation of the wear particles. In the meantime, it was reported that molybdenum oxide film was easily formed on top of aluminium/molybdenum film in a low vacuum annealing at a temperature of 450°C [19], therefore, some molybdenum oxides might be formed with the help of oxygen from Al_2O_3 ball with the progress of tribo-test.

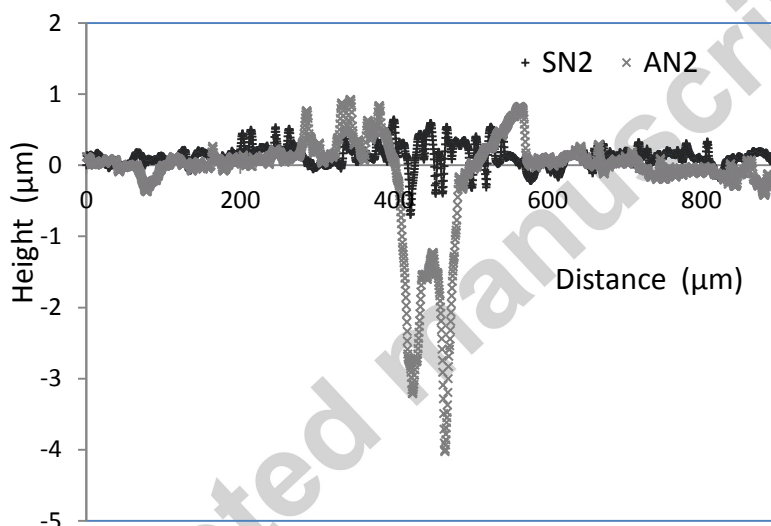
Figure 6. The wear tracks on TZM sample after tribo-test against different counterpart balls in a nitrogen gas atmosphere.

As shown in Figure 6, the profiles of the wear tracks for AN2 and SN2 tested TZM surfaces are in big contrast: two deep grooves produced by an Al_2O_3 ball (AN2) verse multiple shallow-grooves produced by a Si_3N_4 ball (SN2). SEM observations (Figure 7) of these two wear tracks revealed different features: deep and wide grooves with side loose flakes for the former and shallow and narrow abrasive multi-grooves for the latter. EDX analysis of the oxygen content detected was much lower in the deep groove than in the flake along the wear track (Figure 7a). This is similar to the results shown in Figure 3d under AA4 conditions. In the meantime, a much bigger wear scar on the counterpart alumina ball was observed by optical microscopy. This means that severe wear also occurred to the counterpart ball. Some silicon information can be picked up in the multi-grooves (Figure 7b point 1) suggesting some Si_3N_4 particles from the ball was transferred into the track and contributing to the wear of the grooves.

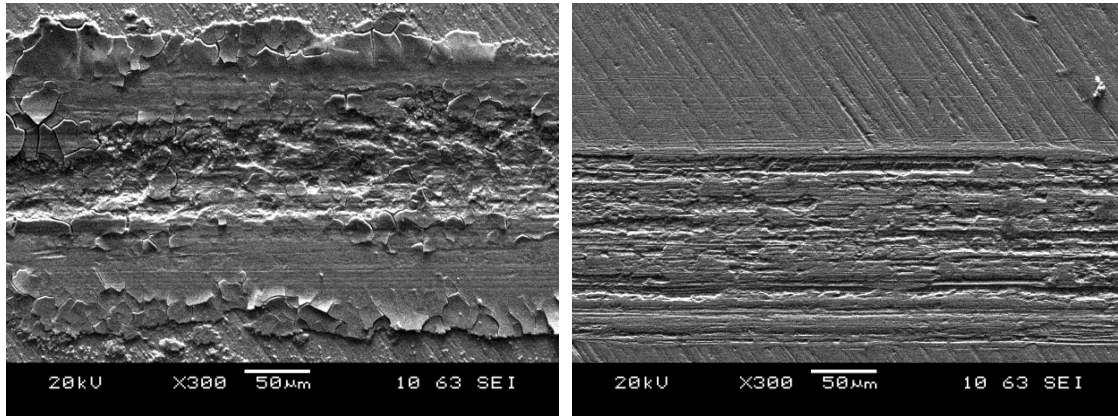
Wt%	O	Si	Ti	Mo
1	12.48	6.60		80.92
2				100.00
3			0.55	99.45

Figure 7. Wear tracks of (a) AN2 and (b) SN2 after friction test in nitrogen (c) EDX analysis.

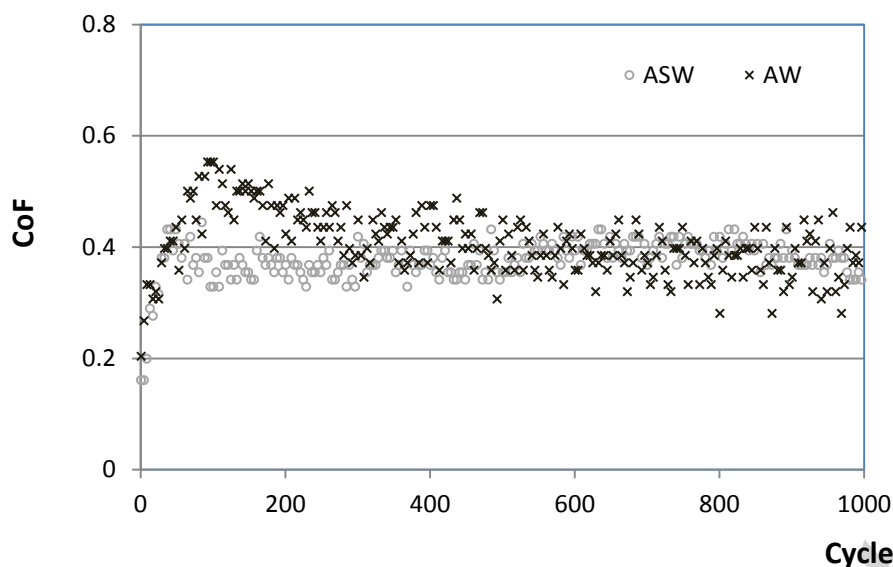
Figure 8. The CoFs of TZM reciprocating against an Al_2O_3 counterpart ball in distilled water and salted water.

Figure 8 shows the CoFs of the TZM alloy reciprocating against an Al_2O_3 counterpart ball in distilled and salted water. The initial CoFs were low when the friction counterparts were submerged in distilled or salted water. The CoF in distilled water (AW) increased steadily to about 0.58 after about one hundred cycles, and then gradually reduced to about 0.4 after 1000 cycles (Figure 8). After an initial low value, the CoF in salted water (ASW) gradually climbed up and remained quite stable at around 0.4 until the end of the tribo-test. Overall, they are quite similar except for a heap for AW between 100-250 cycles.

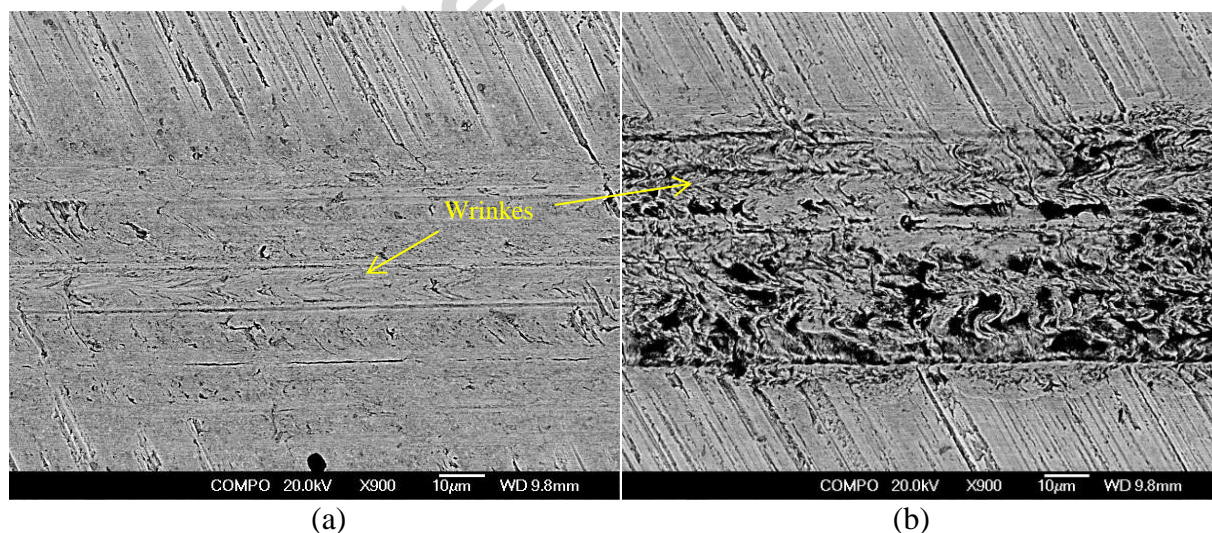
Figure 9. Wear tracks after tribo-test under lubricant of: (a) distilled water (AW), (b) 3.5% NaCl water (ASW)

No measurable wear could be detected by a 3D profilometer for the ASW and AW samples after reciprocating against an alumina counterpart ball in distilled water and salted water. However, SEM observations revealed different features for these two tested samples. As can be seen in Figure 9a, the wear track of AW tested sample shows polished trace with very fine scratch lines and ripples. In contrast, although no measurable wear as for AW tested sample, the wear track of the ASW tested sample developed severe ripples and corrosion pits (Figure 9b), indicating poor corrosion resistance of TZM alloy to NaCl.

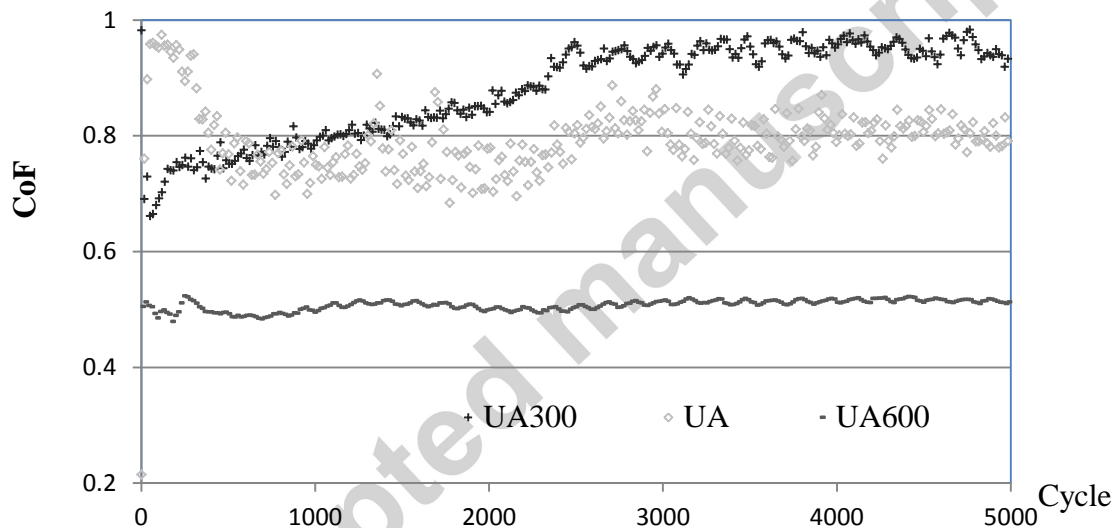
Figure 10. The coefficient of friction between Al_2O_3 ball and TZM sample as a function of the testing temperature.

Unidirectional pin-on-disc friction and wear tests of TZM alloy against an alumina ball at room temperature (UA), 300°C (UA300) and 600°C (UA600) in the air were conducted. The CoFs of these three systems are compared in Figure 10. It can be seen that at room temperature, the CoF of UA was very high in the first 400 cycles, and then it decreased to about 0.76 for about 2000 cycles before slightly increased to around 0.8 with a few jerks in the test process (Figure 10). When tested at 300 °C, after a few run-in cycles with high friction, the CoF of UA300 decreased to about 0.65 at cycle 20 and then increased gradually to above 0.9 at 2400 cycles and kept constant but with a fluctuation from 0.9 to 1.0 until the end of the test. Interestingly, when tested at 600 °C, apart from the short running-in process, the CoF of UA600 showed a constant low value of 0.5 for the whole tribo-test cycles.

As shown in Figure 10, when tested at RT the initial CoF of UA reached about 0.9 before it reduced to about 0.7-0.8 after about 500 cycles. The initial CoF of the UA (Figure 10) is much higher than that of the AA2 (Figure 1a) when both tested in air and under the same normal load of 2N. This could be explained by the difference in the applied contact stress and in the mode of movement. Firstly, the diameter of the alumina ball used in the unidirectional UA test (6 mm) was smaller than that (8 mm) used in reciprocating AA2 test, which led to a higher contact stress and larger plastic deformation at the interface. Secondly, in unidirectional sliding, the formation and growth of adhesion junctions could continue with the one direction sliding; on the other, hand, the formation and growth of adhesion junctions could be intermittently stopped by the reciprocating action in the AA test. Hence, the extremely high initial CoF observed from the unidirectional sliding UA test could be the consequence of severe adhesion and rapid growth of adhesion junctions at the beginning. Then the CoF gradually reduced to 0.7-0.8 mainly due to friction-induced mild oxidation; however, it remained high and sometimes jogging due to the fragments trapped in the wear track, thus causing abrasion. This is evidenced by the very rough wear track surface (Figures 11a and 12a).

The lowest CoF about 0.5 was observed when TZM was tested at 600 °C (Figure 10). This may be attributed to the formation of lubricious oxides (MoO_3 and/or Mo_4O_{11}) thin film on the surface at high temperature although $\text{Al}_2(\text{MoO}_4)_3$ compound might also be formed at this temperature range which has been reported elsewhere[16, 20]. In the tribo-test, due to the high test temperature the formation of the oxide film is most probably faster than the wear, thus maintaining the self-lubrication of the oxide film on the surface in the whole process. This is clearly supported by the black (Figure 12c) and smooth (Figure 11a), the low friction (Figure 10) and the very low wear rate (Figure 11b).

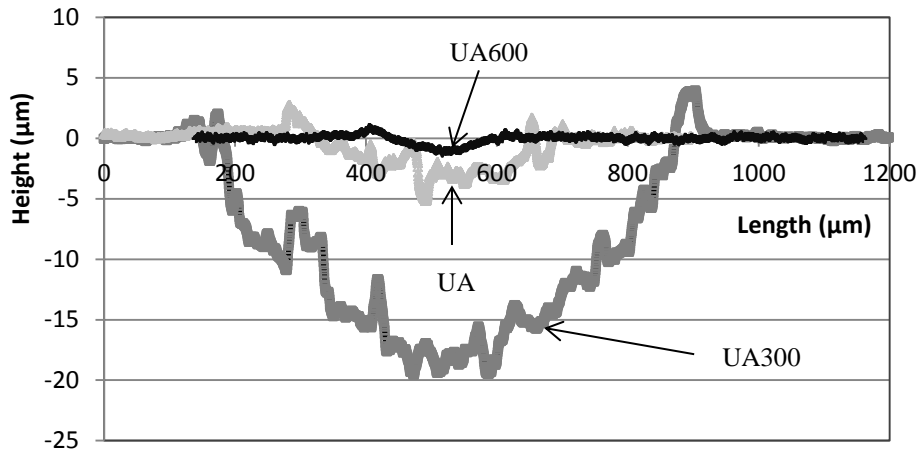
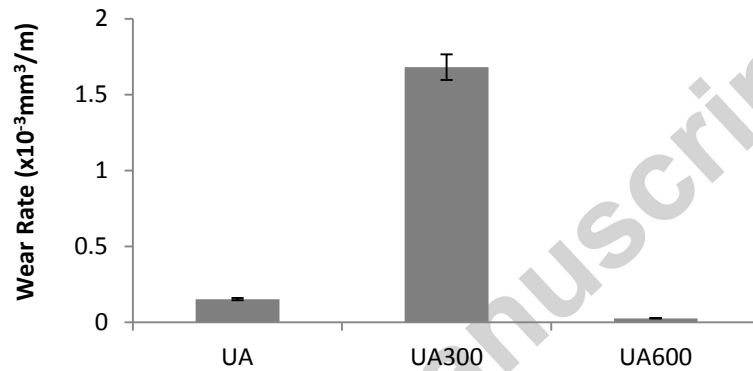
Figure 11. The wear tracks on TZM sample after unidirectional tribo-test at different temperatures: (a) track profile and (b) wear rate.

As shown in Figure 11a, when tested at room temperature, the wear track of UA is shallow (about 2.5-5.0 μm) with a rough surface. When tested at elevated temperatures, the wear track of UA300 showed severe material removal with a much wider and deeper wear track (18-20 μm) as compared with that formed at room temperature. However, the wear track of UA600 revealed a large contrast to that of UA300 with only a fraction of the wear loss comparing to UA300. The wear rates at different temperatures were calculated and plotted in Figure 11b, and it was found that the wear rates were 0.152, 1.68 and $0.0258 \times 10^{-3} \text{ mm}^3/\text{m}$ for UA, UA300 and UA600 respectively, and the UA600 achieved best wear resistance under the unidirectional test conditions.

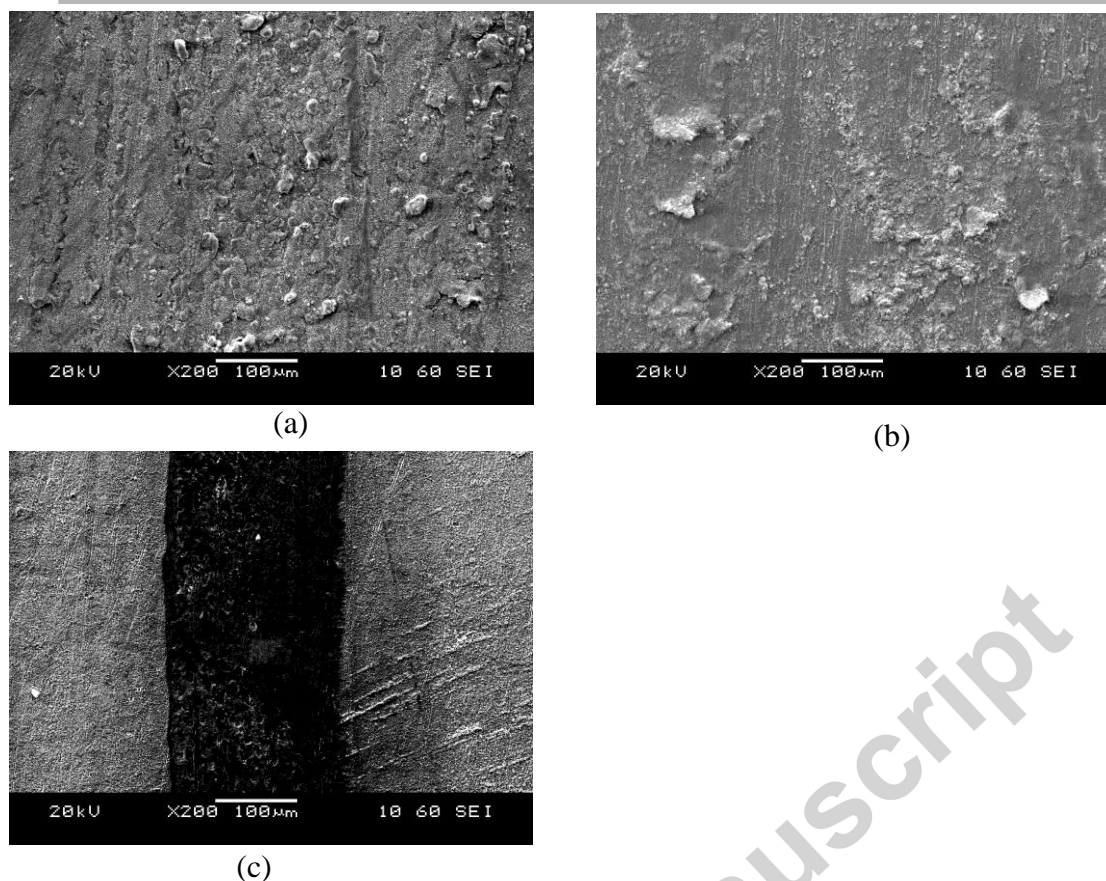
Figure 12. Wear tracks after unidirectional friction test at different temperatures: (a) at room temperature (UA), (b) 300°C (UA300) and (c) 600°C (UA600).

SEM observations on the wear tracks formed in the tested samples revealed that, when tested at room temperature, there were some flakes left on the wear tracks which were similar to that formed on the reciprocating tested sample (Figure 12a). When tested at 300 °C, the worn surface was covered by a lot of bulged lumps (Figure 12b). In contrast, after a test at 600 °C, the wear track became dark and relatively smooth with only some scattered bumps were left on the track (Figure 12c).

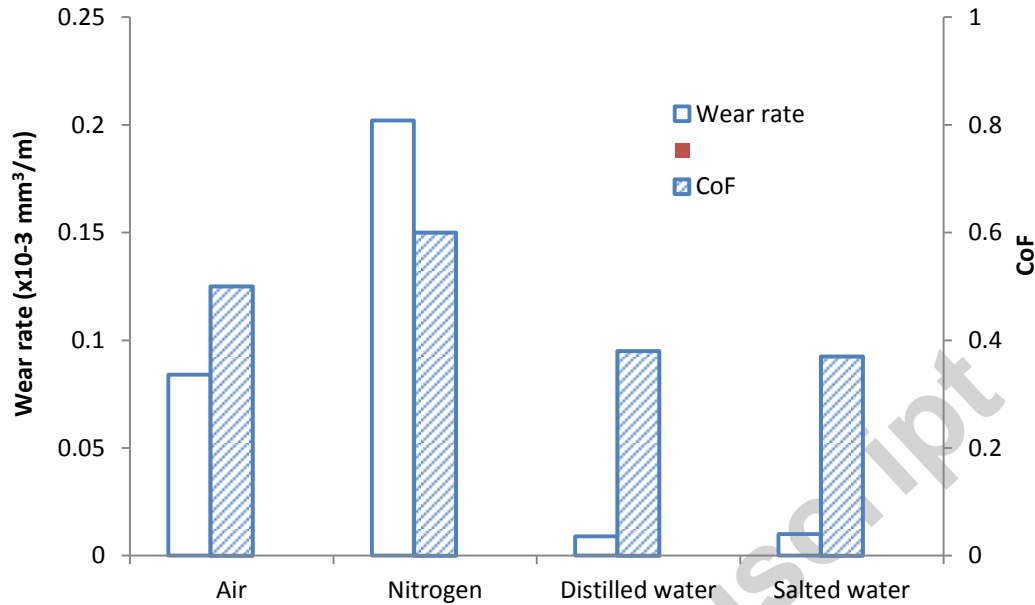
Figure 13. Wear rate and average CoF (shaded) after friction test utilising a $\Phi 8$ mm Al_2O_3 ball under a load of 2 N for 1000 cycles in different mediums.

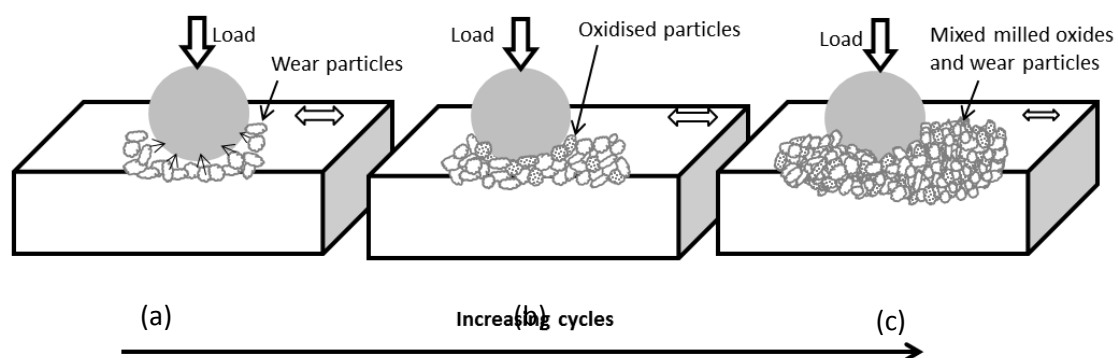
Figure 14. Schematics of tribological interaction between an Al₂O₃ ball and TZM sample Under a load of 2N (AA2), most of the oxidised flaky pieces were not removed due to reduced shear force. Therefore a mild tribo-oxidative friction prevailed, and overall, the

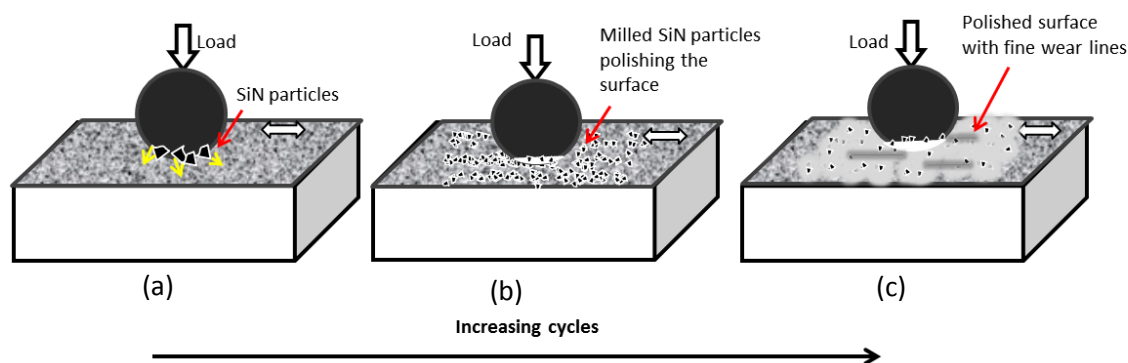
Figure 15. Schematic of friction between a Si_3N_4 ball and TZM sample

It is known that MoSi_2 is brittle ($1\text{--}2 \text{ MPa m}^{1/2}$) with a hardness about 12–14 GPa at temperatures below 1000°C . Therefore, some wear particles came off from the Si_3N_4 ball as schematically shown in Figure 15a. A small flat surface would be created, the contact area increased and thus the contact stress reduced. Due to the brittleness and relatively low hardness, the wear particles were milled into fine particles, which polished the TZM surface (Figure 15b) and created localised scratches (Figure 15c). This is supported by the wear track morphologies shown in Figure 4a and the large flat wear scar formed on the silicon nitride ball (Figure 4b). Therefore, unlike the test against Al_2O_3 ball, chemical and abrasive wear rather than adhesive wear dominated the tribo-test against a Si_3N_4 ball.
